Manhole Inspection Summary

Manhole # S47I__043MH

Location Address: **2119 bank alley eastern**

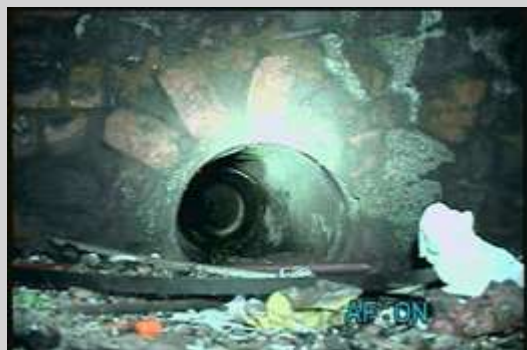
12 O'Clock Outflow

8 in. Circular Gravity Sewer
Pipe Out @ 12 O'Clock

Infiltration: **None** Pipe Seal Cond: **Unknown**
